Aim – To plan a strategy to move the building work development forward towards the Trust’s goal of turning the building into a sustainable community arts centre.

Wiveliscombe Town Hall Building Report 2026

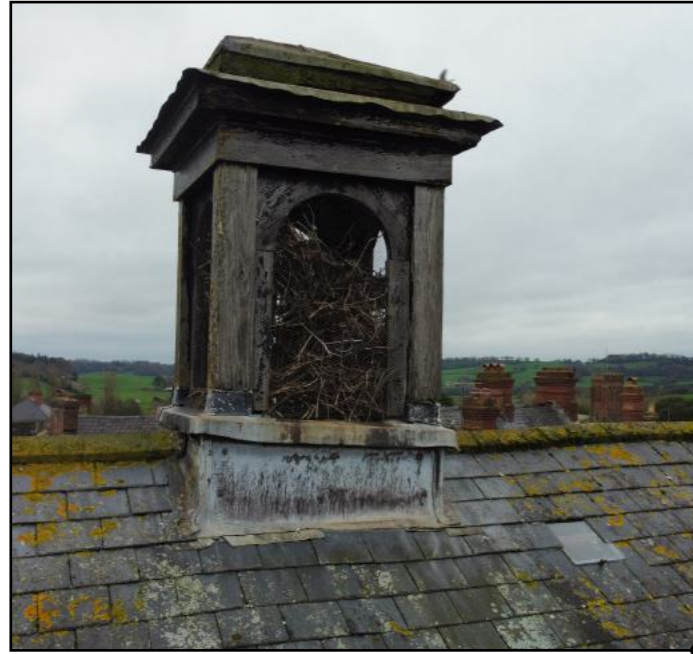
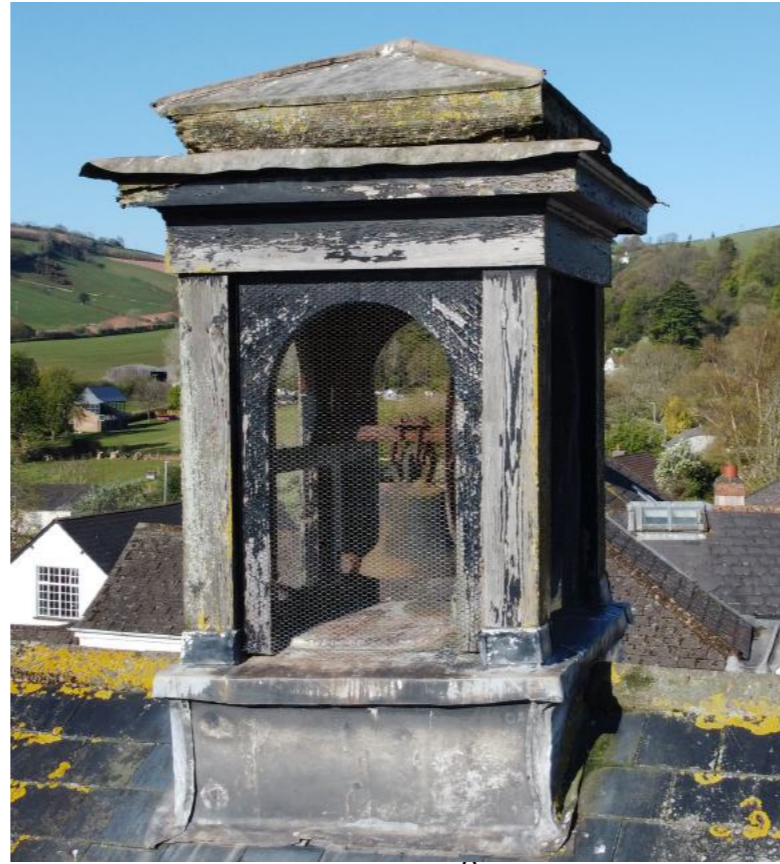
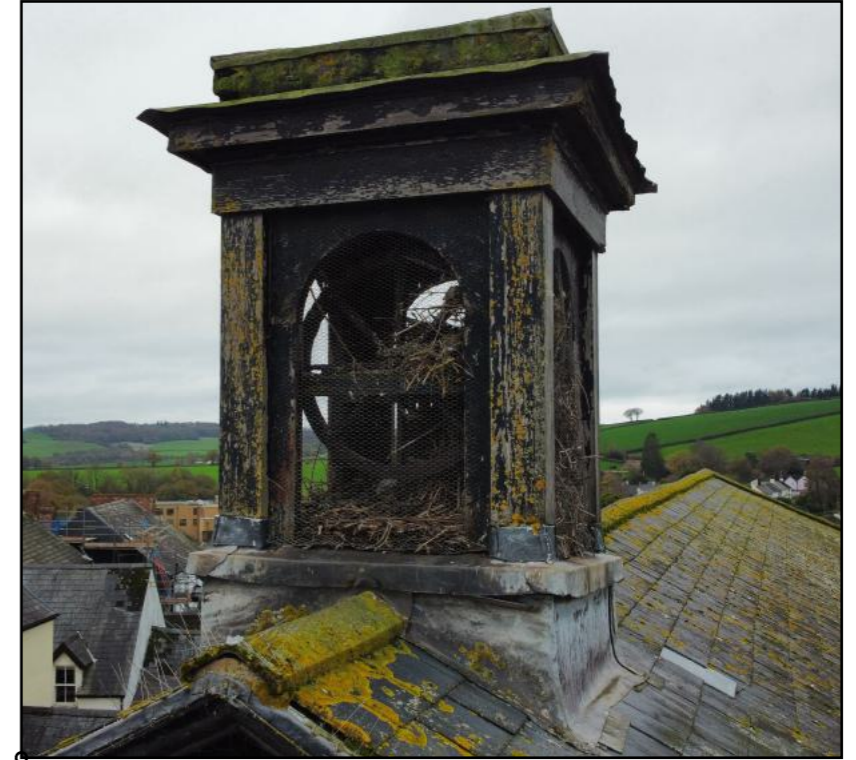
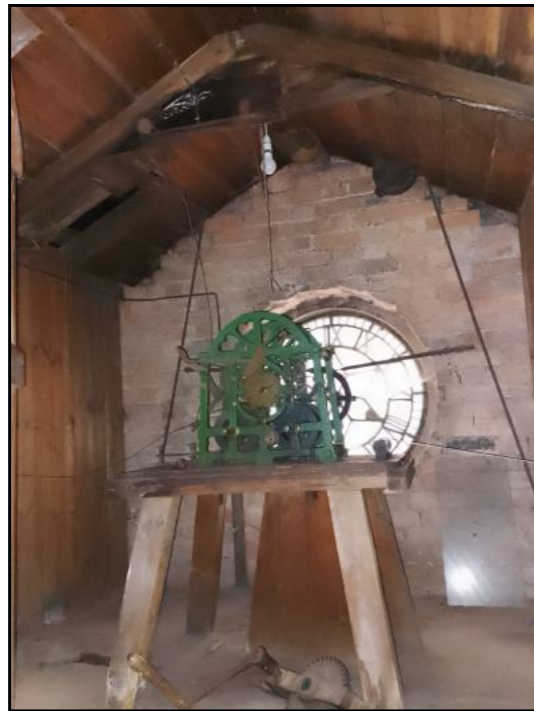
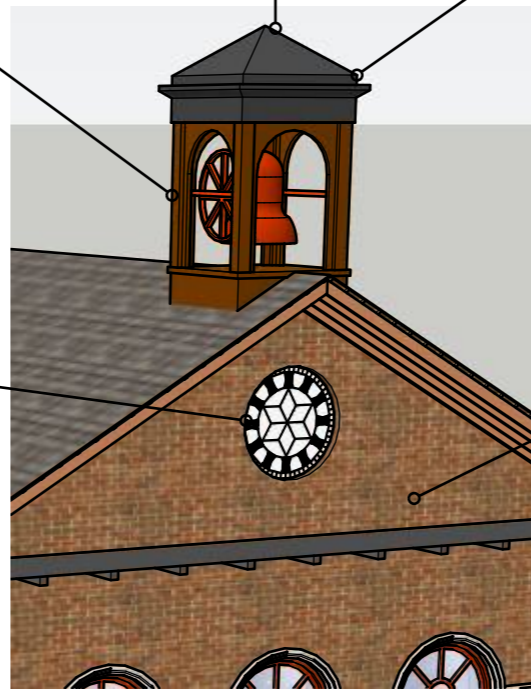
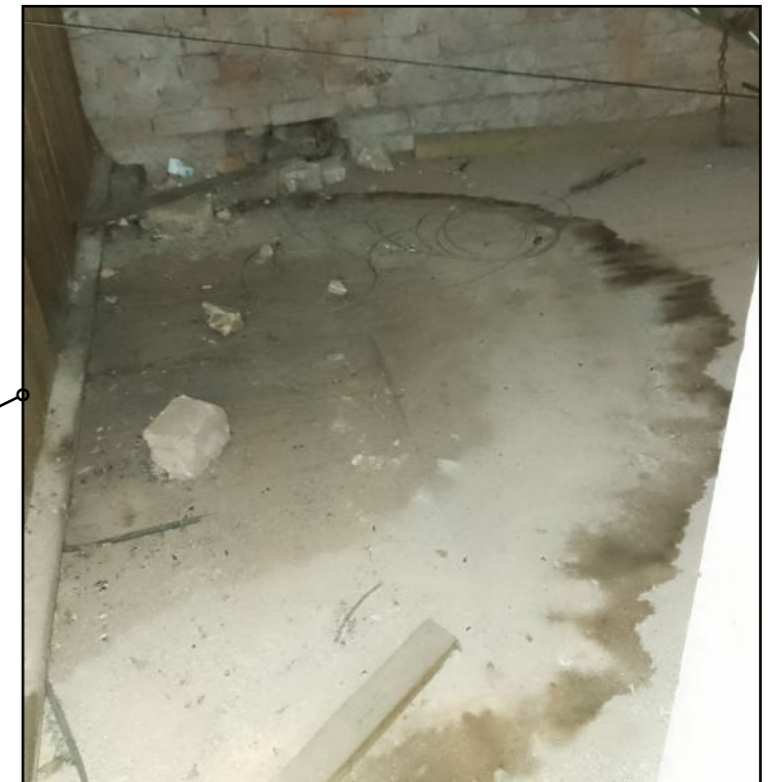
Bellecote Images

- It currently leaks – over the last few years it has gone from a relatively insignificant leak to a priority, especially considering up coming repairs to the ceiling.

- It now leaks into the clock room ceiling and along the rafters, dripping onto the floor but also along the joists and drips onto a section of boards on the ceiling joists above the main Hall.

- Whilst looking from the ground it now appears nesting birds have gained access, and foliage has been growing in the bellcote no doubt adding to the problem.

Damp on rafters in clock room below bellecote

Damp in roof above ceiling of main hall

- We are currently seeking advice as to who is responsible, us or the Landlord.
- **Actions**
 - o **Short-term**
 - This is now a priority. Initially a roofer/surveyor must be found who can do an inspection and report on the work needed to make the bellcote waterproof, bird-proof and safe for the future. This will probably need to be done on a cherry-picker.

- The work then needs to be carried out ASAP; this will most likely include scaffolding at the front of the building (This could then tie-in with window work).

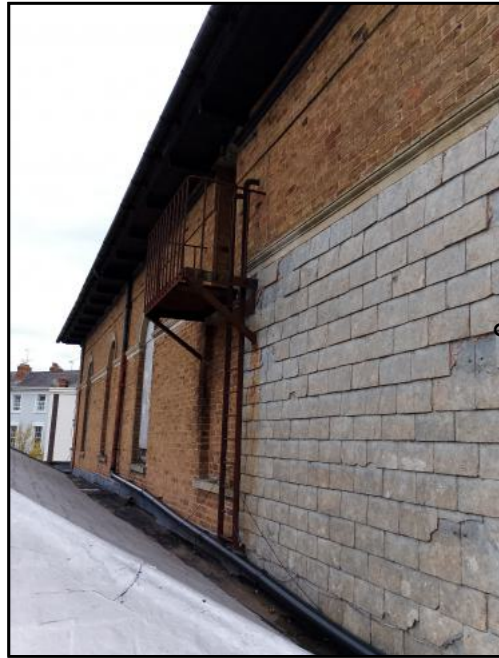
- Access to roof space
 - o This is via a wooden ladder through a wooden hatch
 - o Currently safe and usable
- Fire Exit
 - o There are 2 of these...
 - o One is currently blocked and secure. It was the original exit, and it must have been decided not to use it as a new exit has been smashed through the back wall! The old exit used a fixed vertical access ladder that went down onto the Co-op flat roof.

Old fire escape

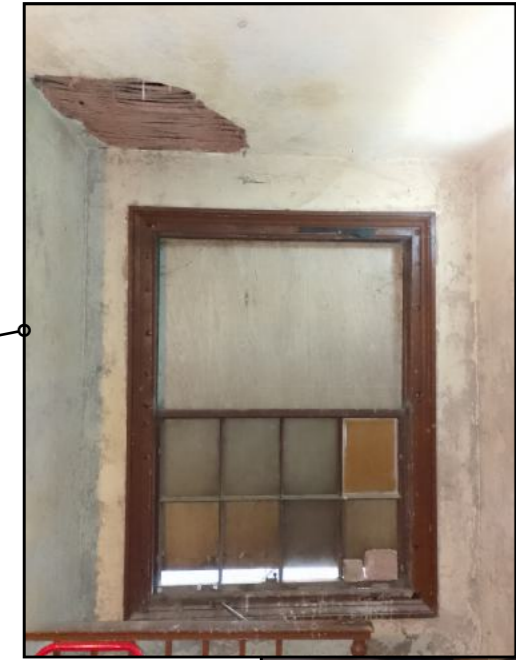
- Window
 - o Only one window which is currently partly boarded up. Wooden sash window and frame with single glazed glass (Half of the window may need replacing) – all in need of repair.

Window

- Secure and insulate the window boarding
 - o **Longterm**
 - Upgrade lighting and power supply
 - Repair and replace the lathe and plaster ceiling
 - Fix and replace the window – consider secondary glazing

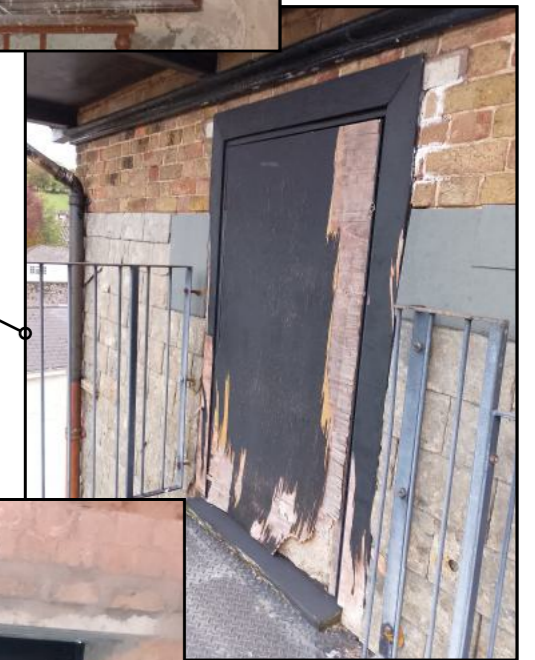
- o The new fire exit was badly made and never finished. There is a large wooden beam across the floor of the exit. The exit is very small. The wooden door itself has had water damage and is not usable – it is fixed shut. (It could be used in an emergency with a kick!)

Interior and Exterior of fire escape

- Actions
 - o **Short-term**
 - Repair the fire exit – door and frame – also repair masonry surround.
 - Make safe the ceiling
 - Make safe the access stairs and handrail

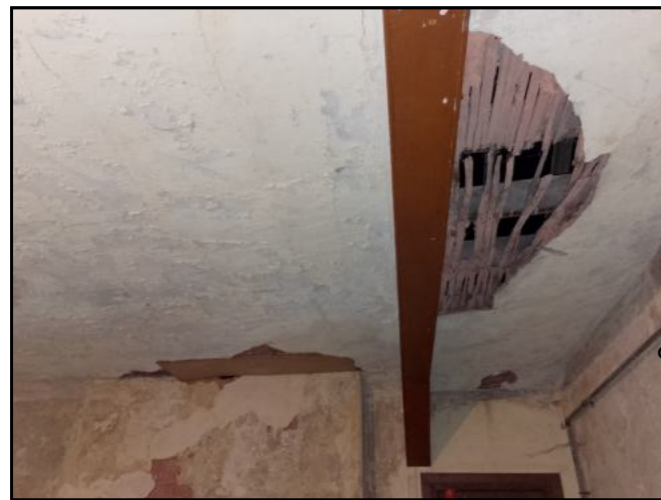
- Ceiling
 - o Currently part of the lathe and plaster ceiling is collapsing, and other areas are clearly loose
- Walls
 - o Main structure appears good, but plaster and paintwork need work

Ceiling damage

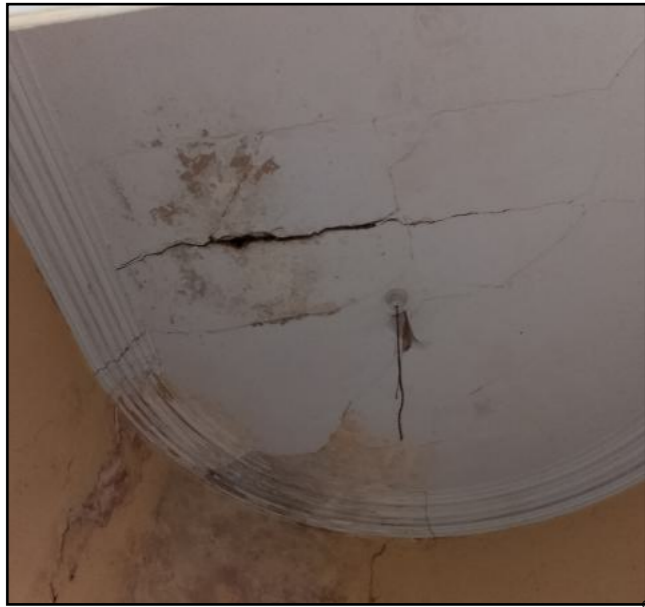
- Ceiling
 - o Currently part of the lathe and plaster ceiling is cracked, and other parts are loose – not to be accessed by the public
- Walls
 - o Main structure appears good, but plaster and paintwork need work

Cracks in ceiling

- Fixtures
 - o Old fire extinguisher – filled with liquid (potentially hazardous?)
- Actions
 - o **Short-term**
 - Whilst work is being carried out on the ceiling of the main hall, an inspection should be carried out into the ceiling condition and the ceiling joists above. (Refer to structural engineer's roof report)

- Make safe the ceiling and repair
 - Bear in mind any changes that may occur during installation of toilet, sink and waste in the rear area of the main hall.

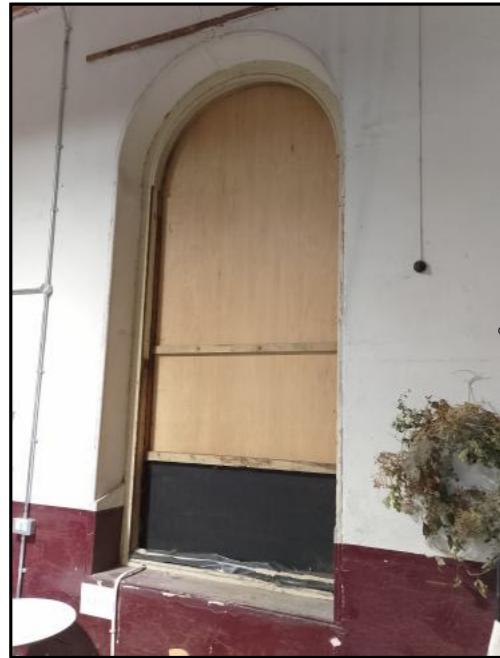
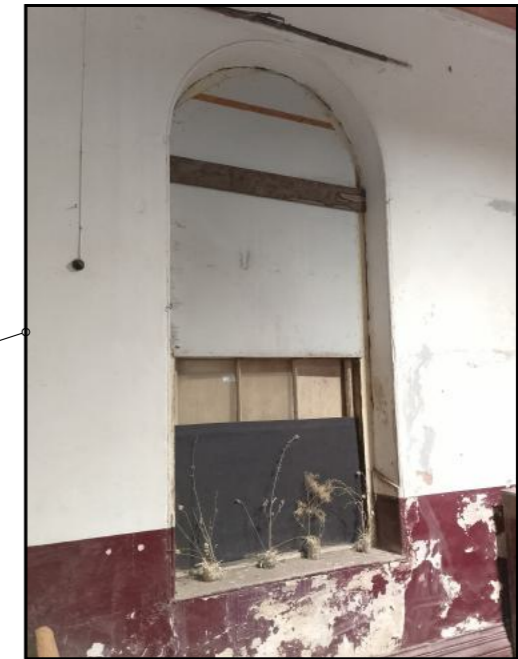
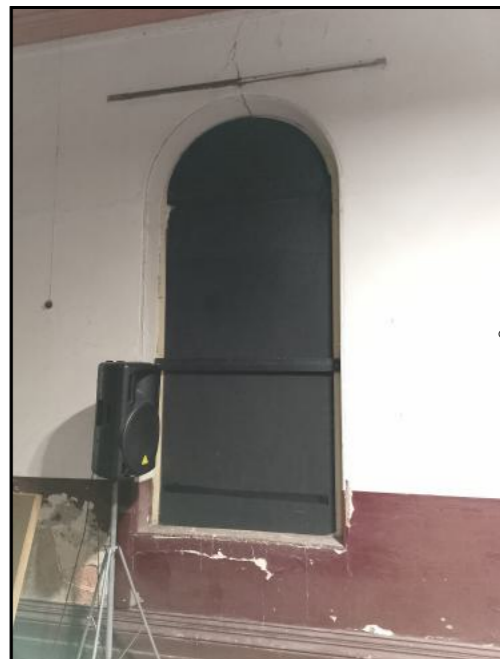
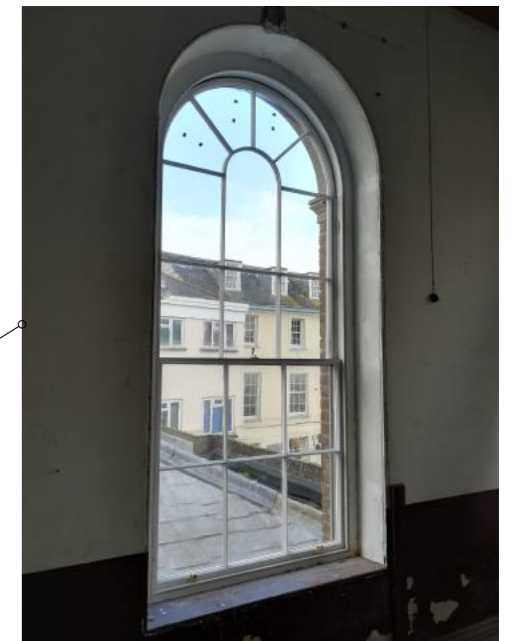
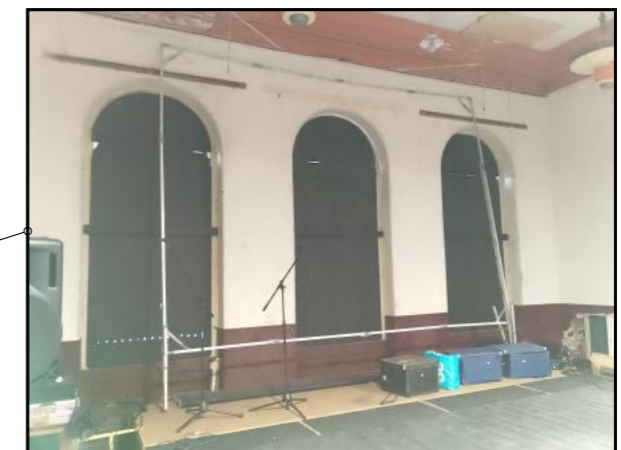
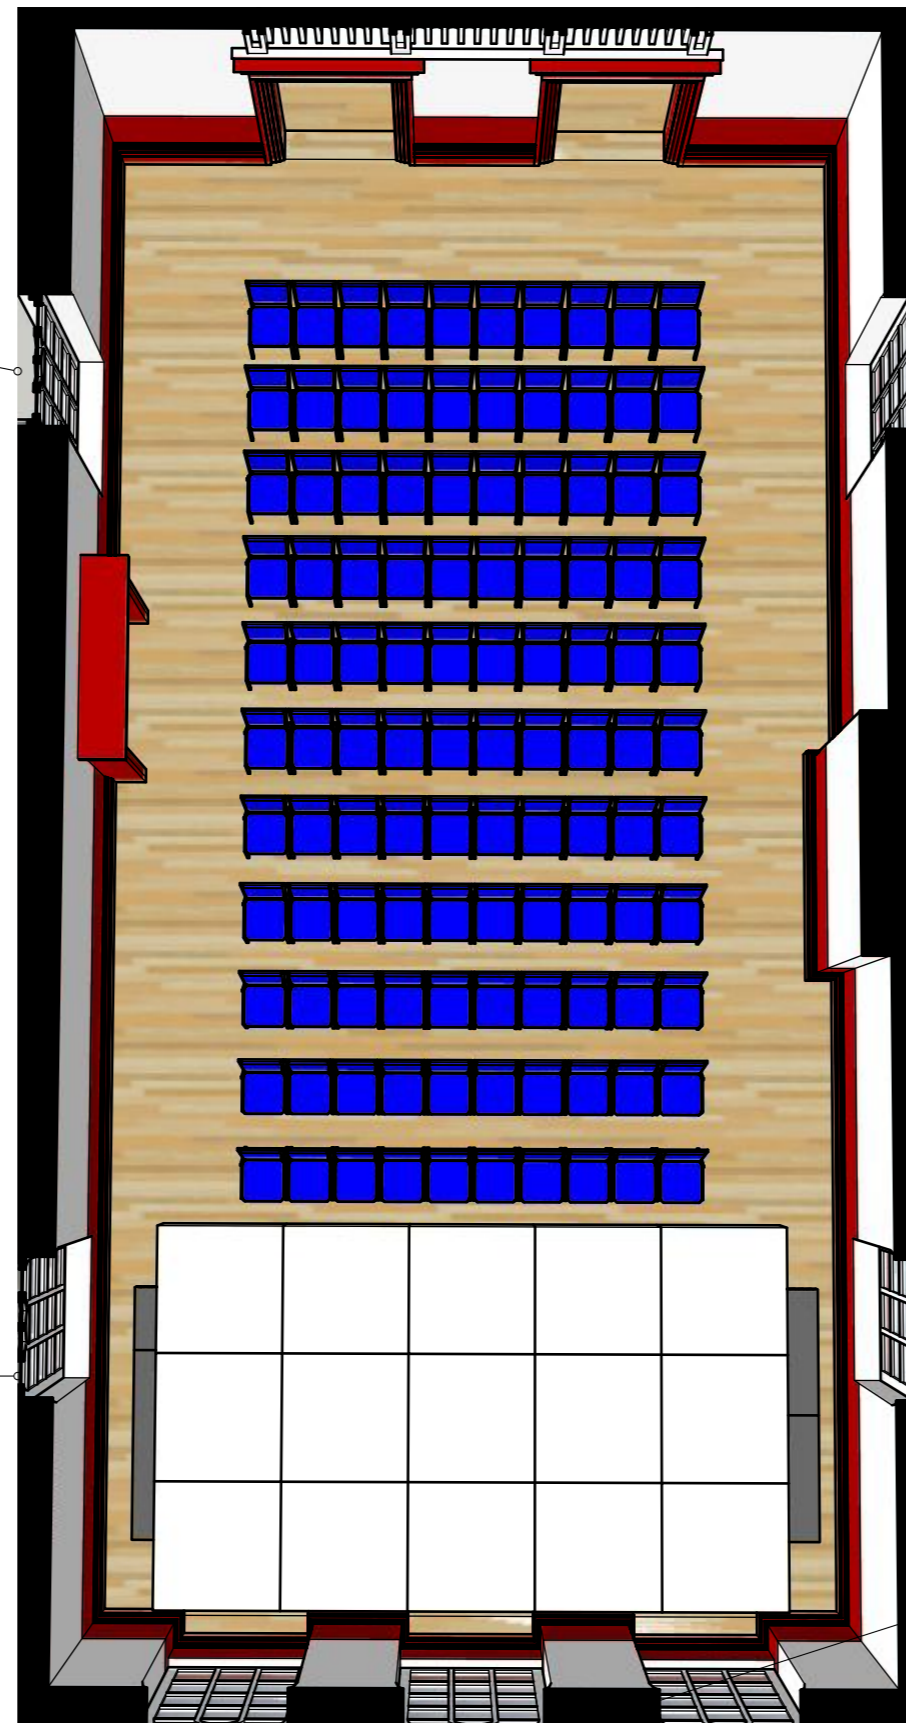
Main Hall Images

- Ceiling
 - o Lathe and Plaster ceiling throughout.
 - o Ceiling has some cracks, small parts missing, plus area of old repairs, all mainly at the North end. Damage caused by historical leaks in the roof that are no longer a problem.

- Cornice
 - o Some damage from old roof leaks
- Walls
 - o Main structure appears good. Cracks at the north end have been monitored with no new movement.

- o 6 other windows in varying states of decay. Some just need wood repairing and re-glazing. Some need to be completely rebuilt.
 - o All windows are currently permanently or temporarily boarded.

- Actions
 - o **Short-term**
 - Repair ceiling where needed and repaint.
 - Repair cornice where needed and repaint.
 - Repair, repaint and refit 3 front arched windows.

- (Could consider shorter term solution to fix clear Perspex over 3 front windows)
 - Renew boarding over other windows to make safe and for insulation (could also consider using clear Perspex to allow more light into Hall).
