Aim – To plan a strategy to move the building work development forward towards the Trust’s goal of turning the building into a sustainable community arts centre.

Wiveliscombe Town Hall Building Report 2026

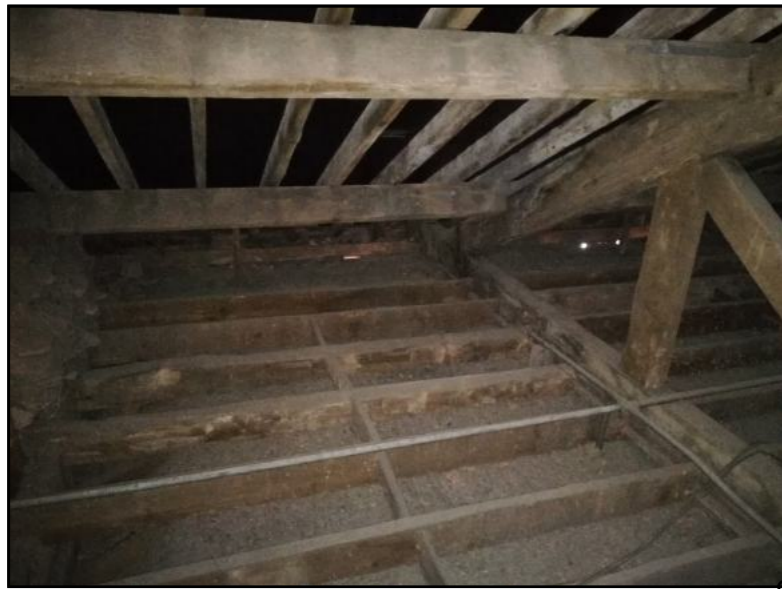
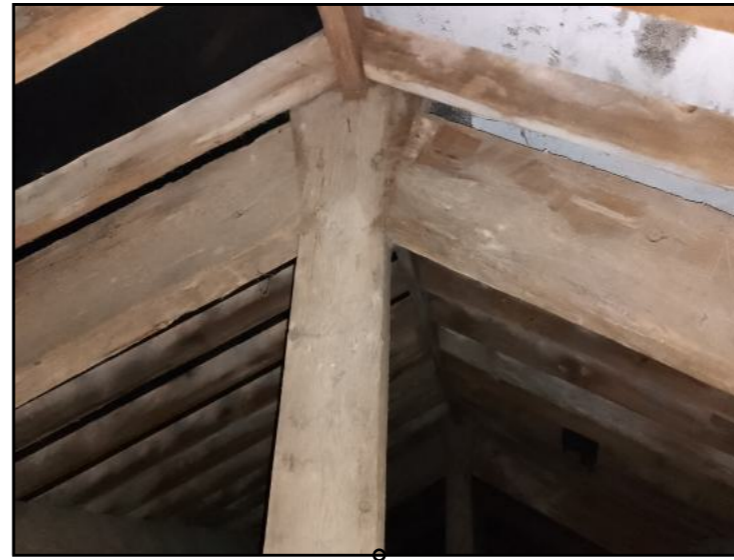
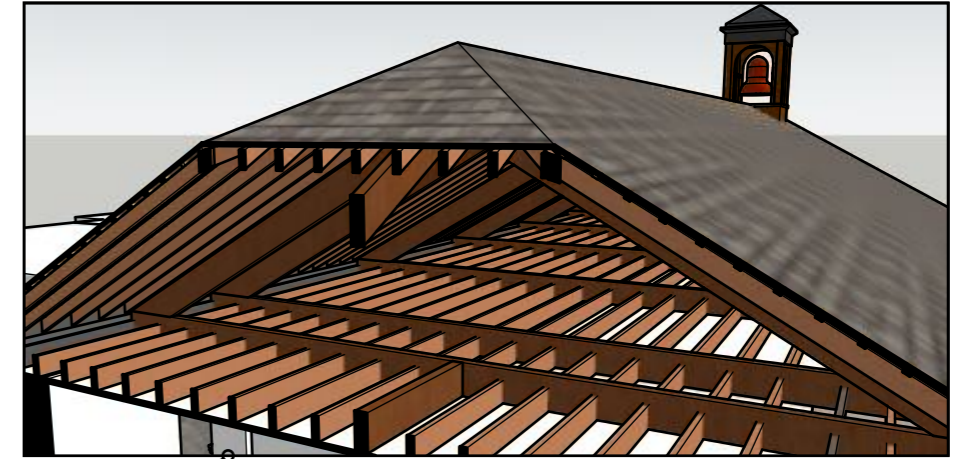
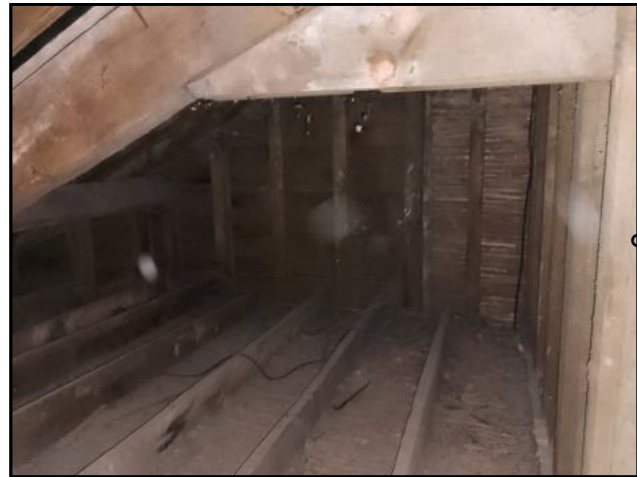
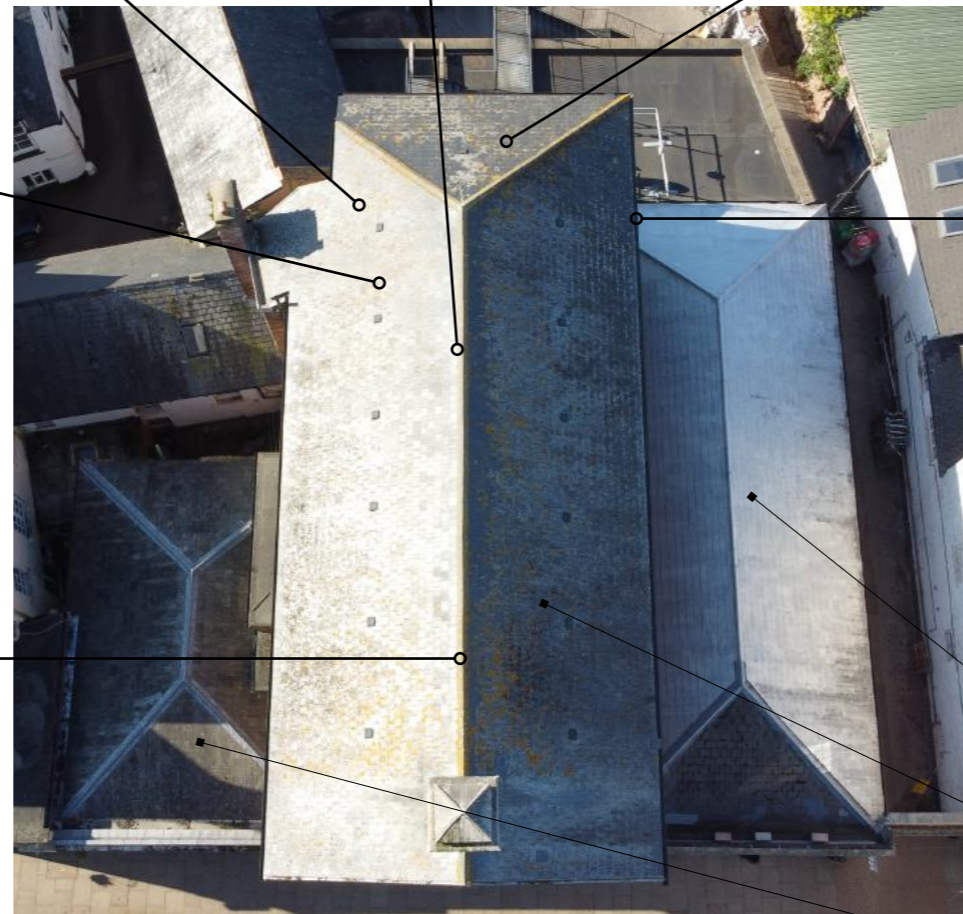
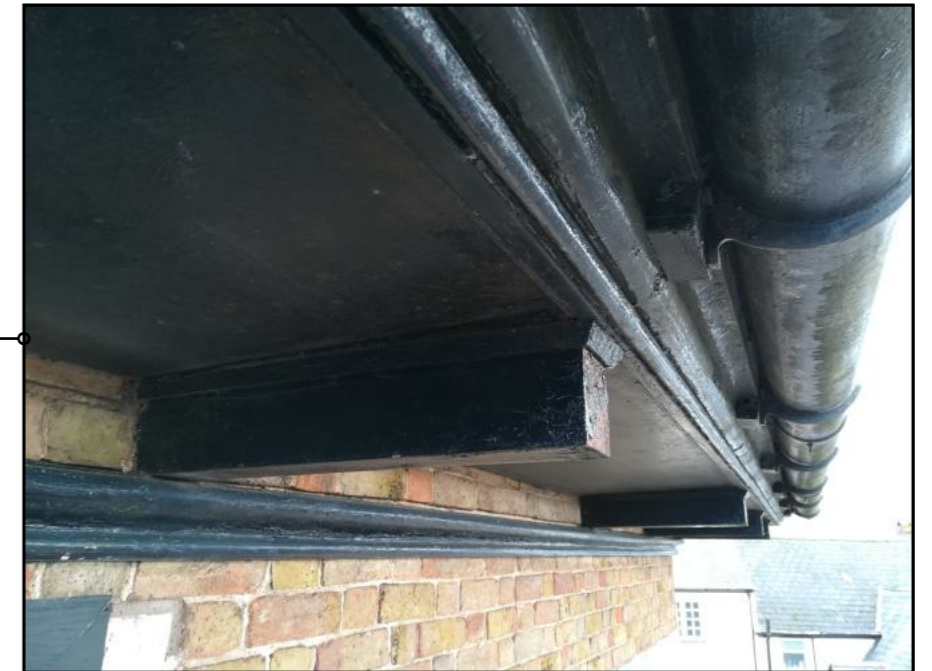
Roof Images

- It currently leaks – over the last few years it has gone from a relatively insignificant leak to a priority, especially considering up coming repairs to the ceiling.

- It now leaks into the clock room ceiling and along the rafters, dripping onto the floor but also along the joists and drips onto a section of boards on the ceiling joists above the main Hall.

- Roof tiles
 - o Covering was renewed in the 90's - looks good for the foreseeable future.
- Wooden roof Structure
 - o Since the tiles were replaced, the roof has been waterproof

- We are currently seeking advice as to who is responsible, us or the Landlord.
- **Actions**
 - o **Short-term**
 - This is now a priority. Initially a roofer/surveyor must be found who can do an inspection and report on the work needed to make the bellcote waterproof, bird-proof and safe for the future. This will probably need to be done on a cherry-picker.

- Insulate the roof space once the ceiling has been repaired.
 - Visual inspection of the gutters, fascias and soffits – report to Landlord.
 - o **Long-term**

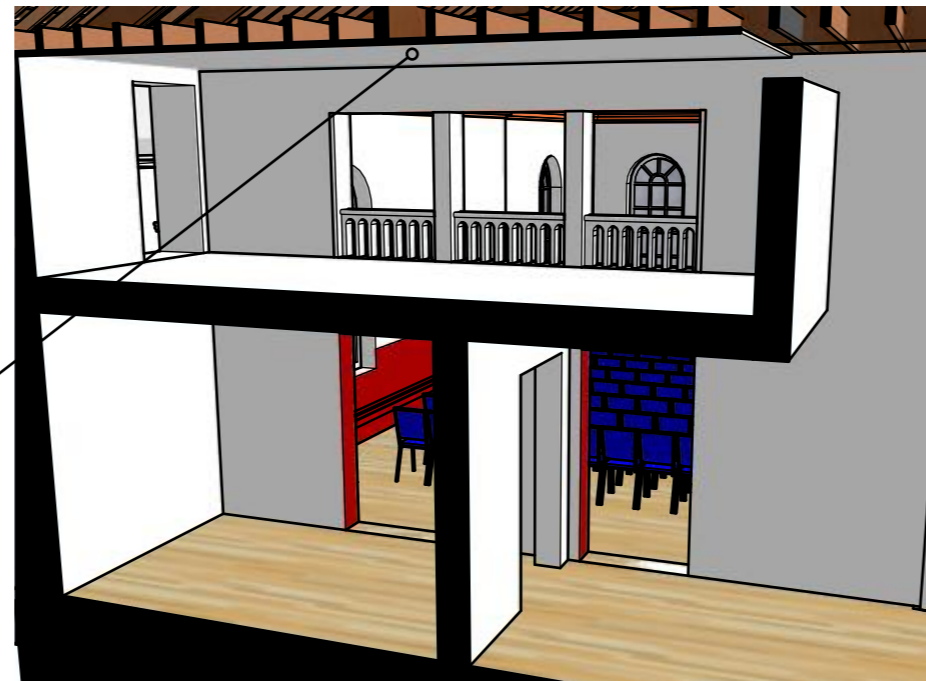
Rear Section

- Ceiling
 - o Currently part of the lathe and plaster ceiling is collapsing, and other areas are clearly loose
- Walls
 - o Main structure appears good, but plaster and paintwork need work

- o The new fire exit was badly made and never finished. There is a large wooden beam across the floor of the exit. The exit is very small. The wooden door itself has had water damage and is not usable – it is fixed shut. (It could be used in an emergency with a kick!)

- Actions
 - o **Short-term**
 - Repair the fire exit – door and frame – also repair masonry surround.
 - Make safe the ceiling
 - Make safe the access stairs and handrail

- Secure and insulate the window boarding
 - o **Longterm**
 - Upgrade lighting and power supply
 - Repair and replace the lathe and plaster ceiling
 - Fix and replace the window – consider secondary glazing

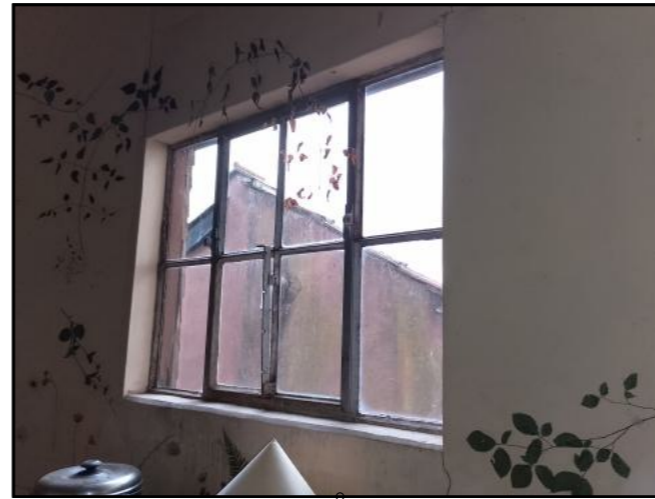
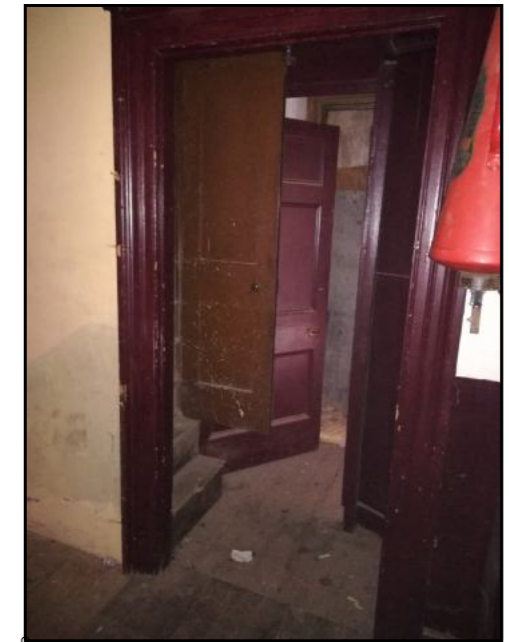
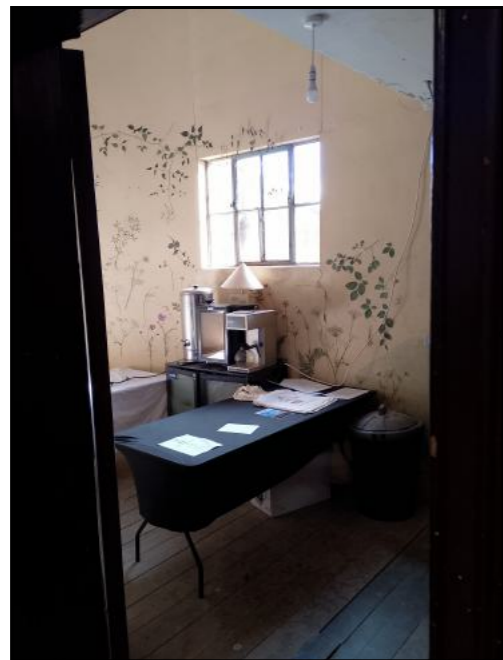
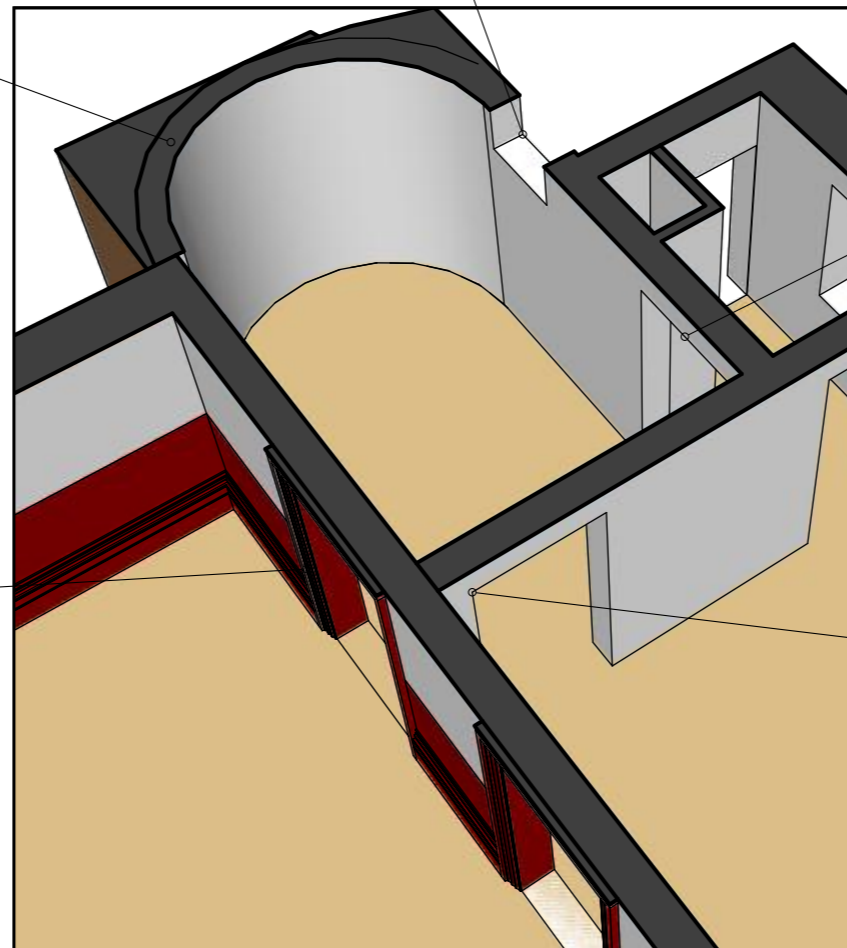
Cracks in ceiling

- Ceiling
 - o Currently part of the lathe and plaster ceiling is cracked, and other parts are loose – not to be accessed by the public
- Walls
 - o Main structure appears good, but plaster and paintwork need work

- Fixtures
 - o Old fire extinguisher – filled with liquid (potentially hazardous?)
- Actions
 - o **Short-term**
 - Whilst work is being carried out on the ceiling of the main hall, an inspection should be carried out into the ceiling condition and the ceiling joists above. (Refer to structural engineer's roof report)

- Make safe the ceiling and repair
 - Bear in mind any changes that may occur during installation of toilet, sink and waste in the rear area of the main hall.

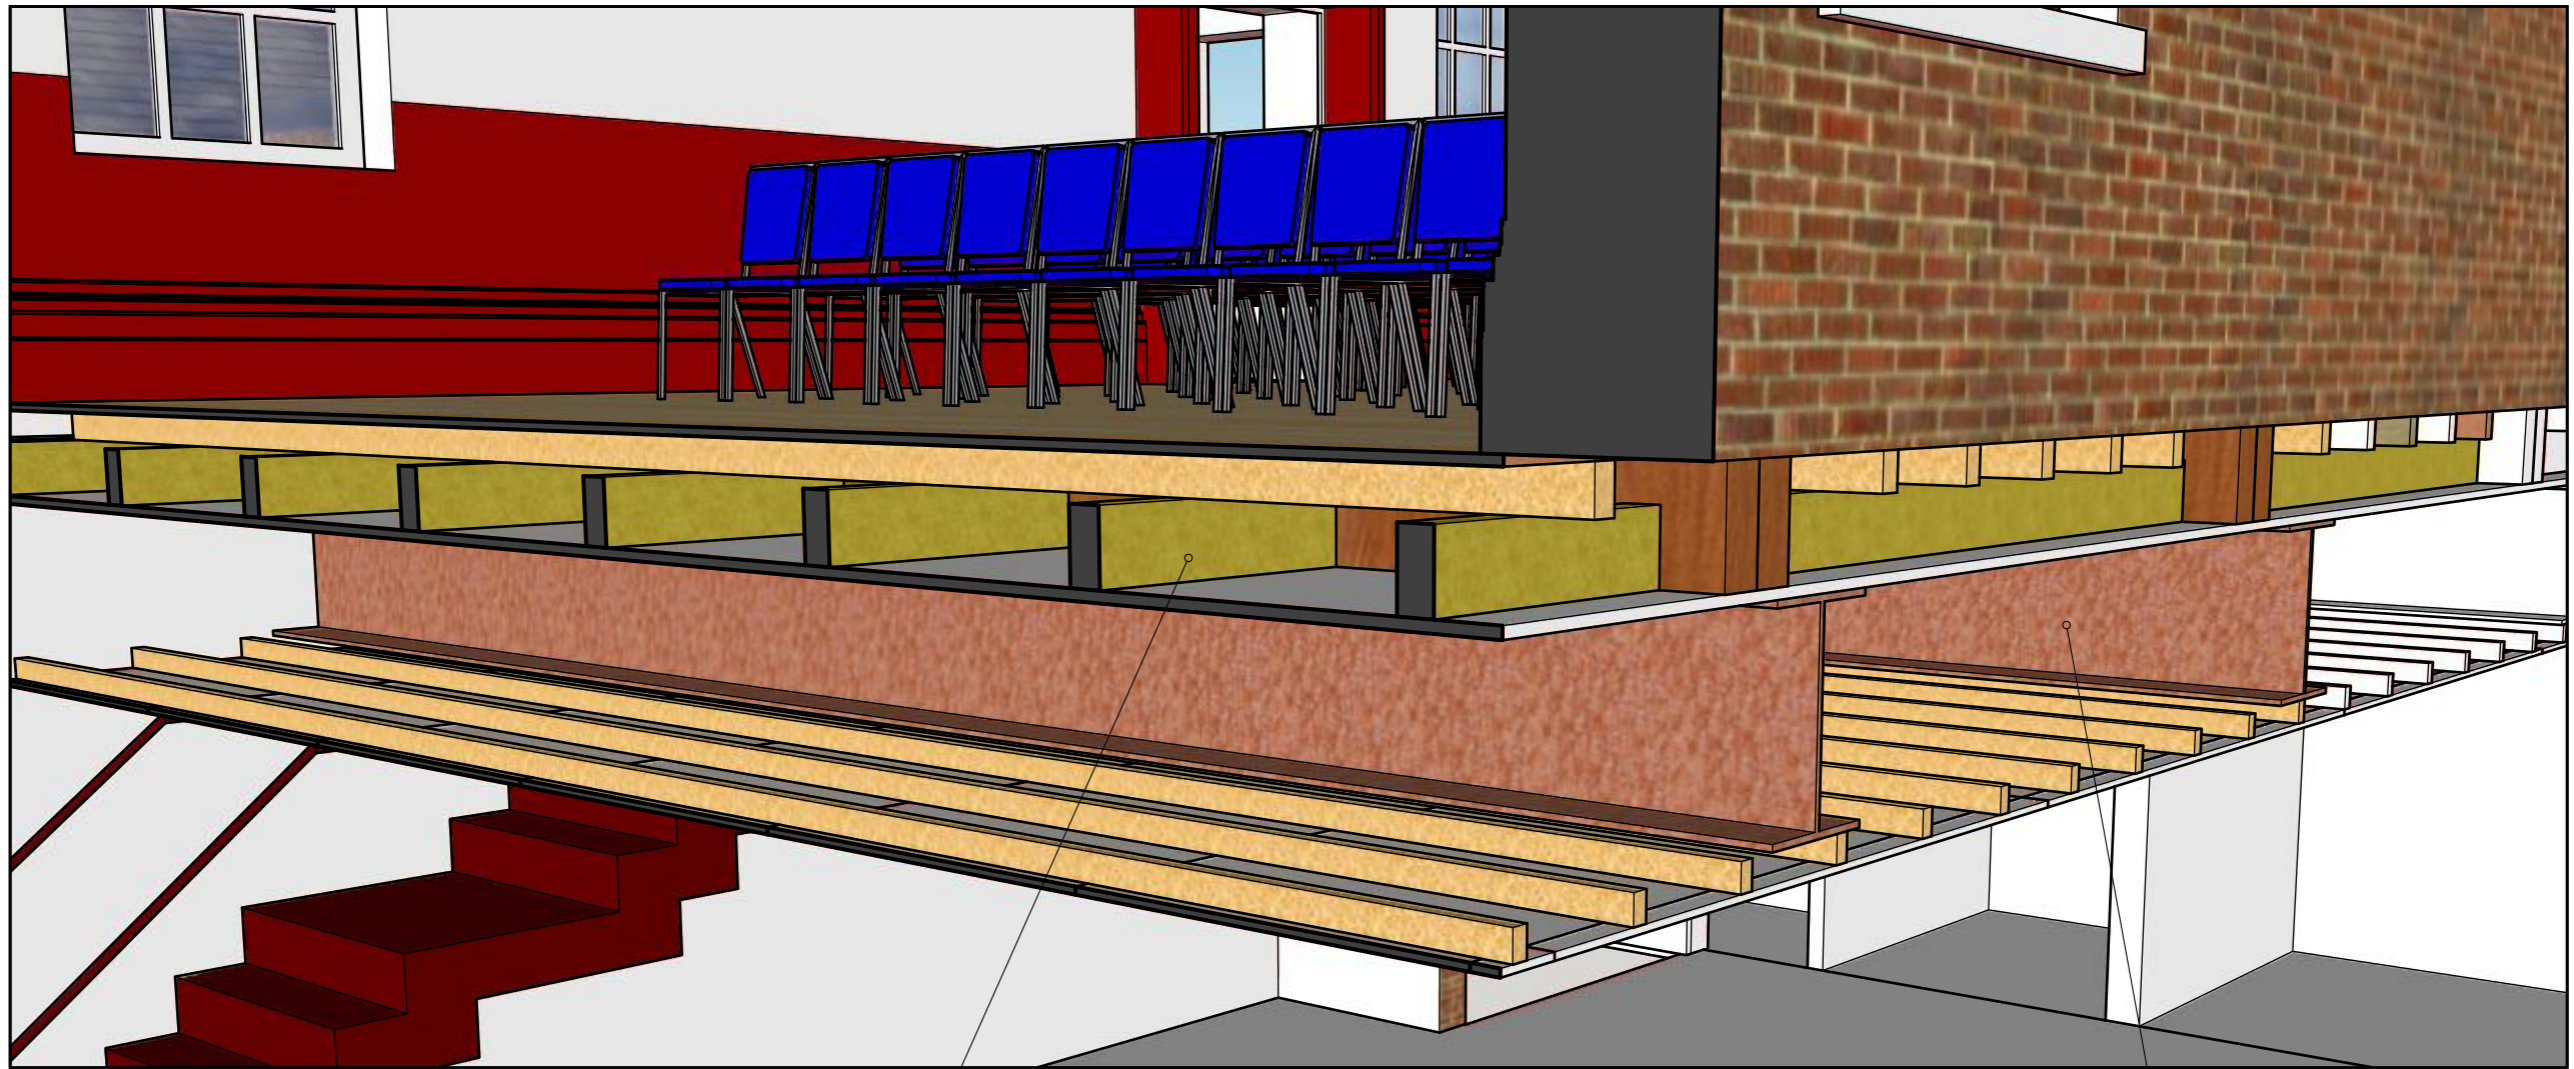
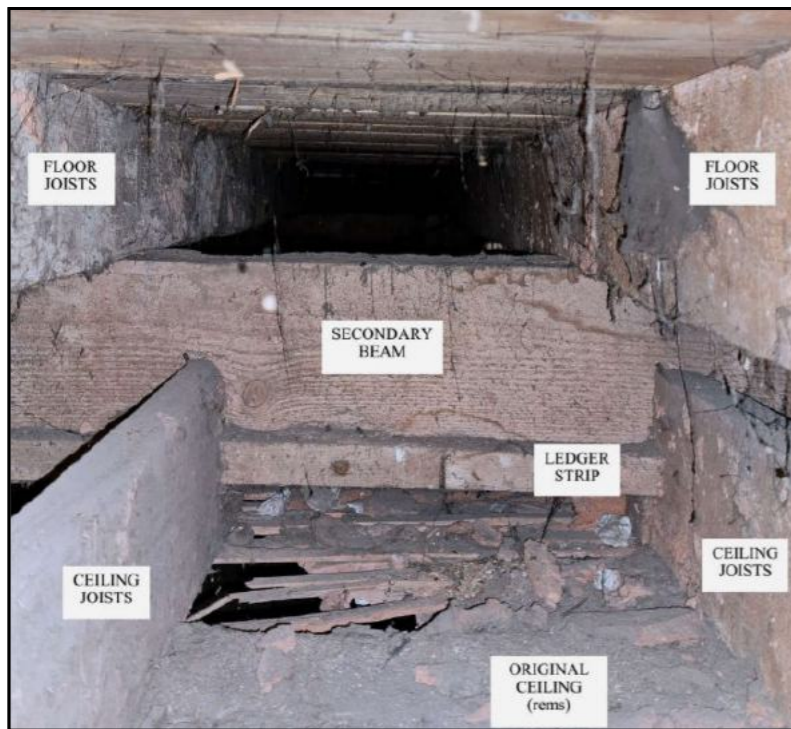
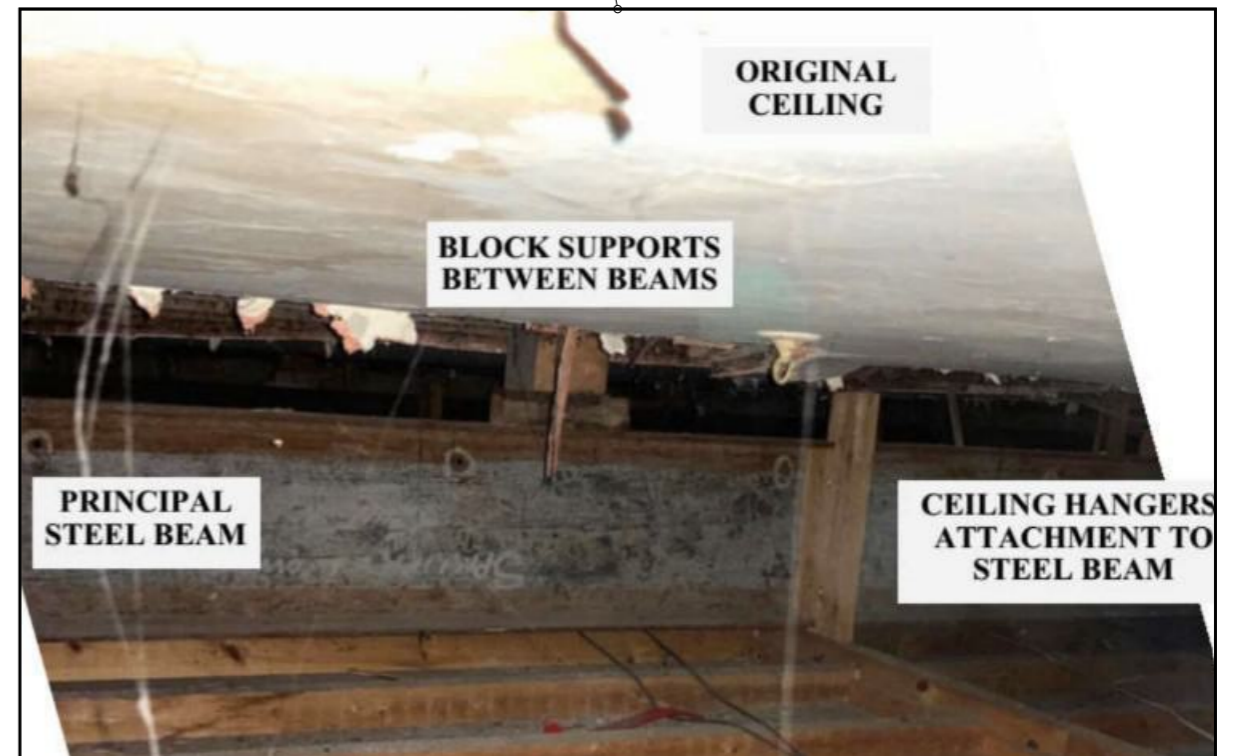
Main Hall Floor

- Ceiling
 - o Lathe and Plaster ceiling throughout.
 - o Ceiling has some cracks, small parts missing, plus area of old repairs, all mainly at the North end. Damage caused by historical leaks in the roof that are no longer a problem.

- Cornice
 - o Some damage from old roof leaks
- Walls
 - o Main structure appears good. Cracks at the north end have been monitored with no new movement.

- Actions
 - o **Short-term**
 - Repair ceiling where needed and repaint.
 - Repair cornice where needed and repaint.
 - Repair, repaint and refit 3 front arched windows.

- Further inspection of flooring to establish danceable strength
 - Secure and replace floorboards where necessary.
 - o **Longterm**
 - Upgrade lighting and power supply

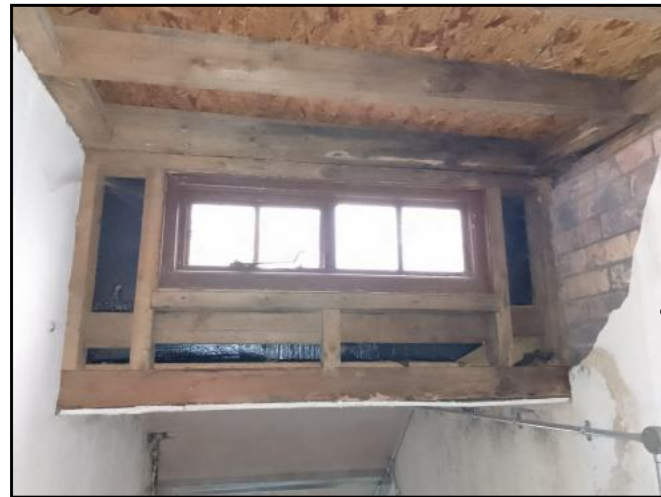
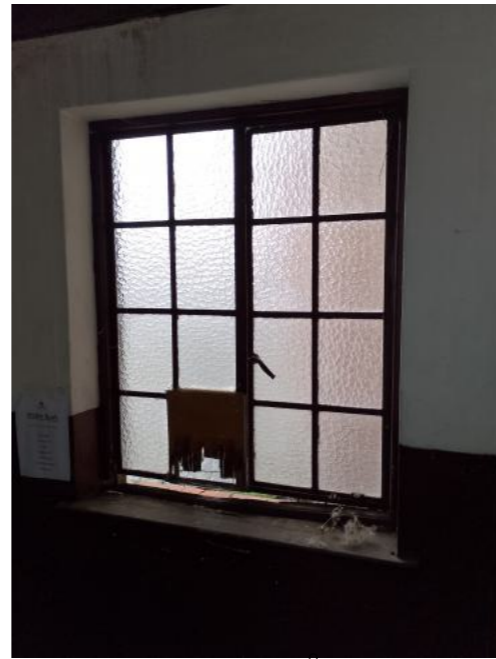
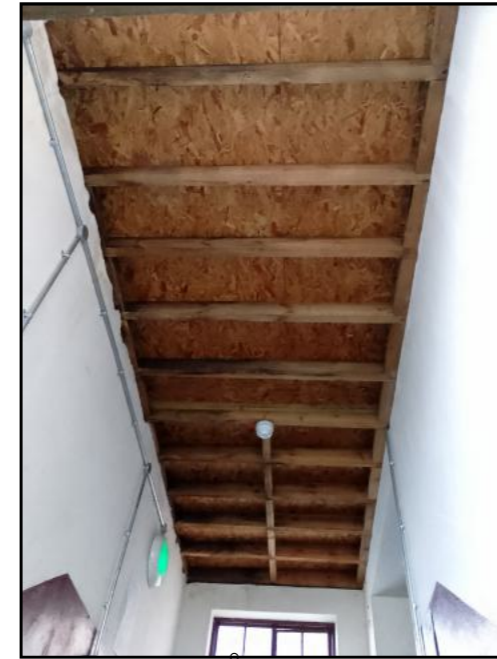
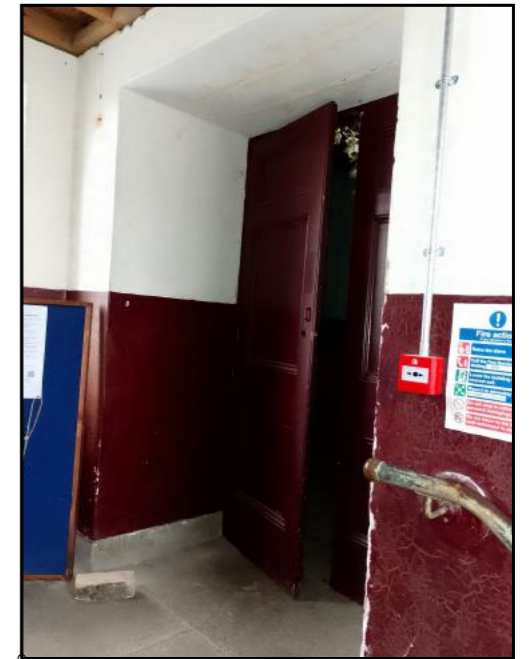
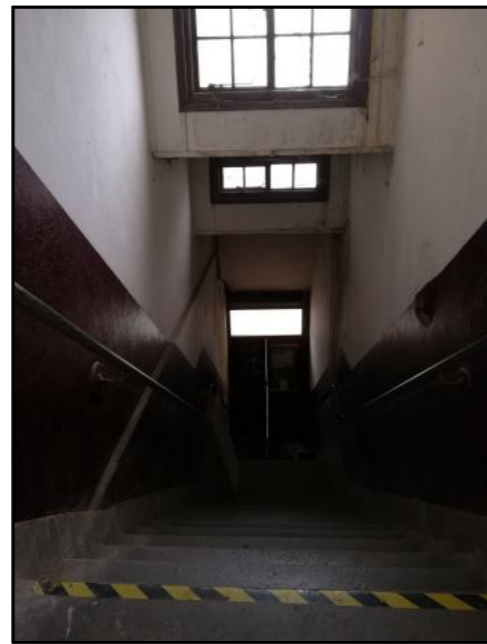
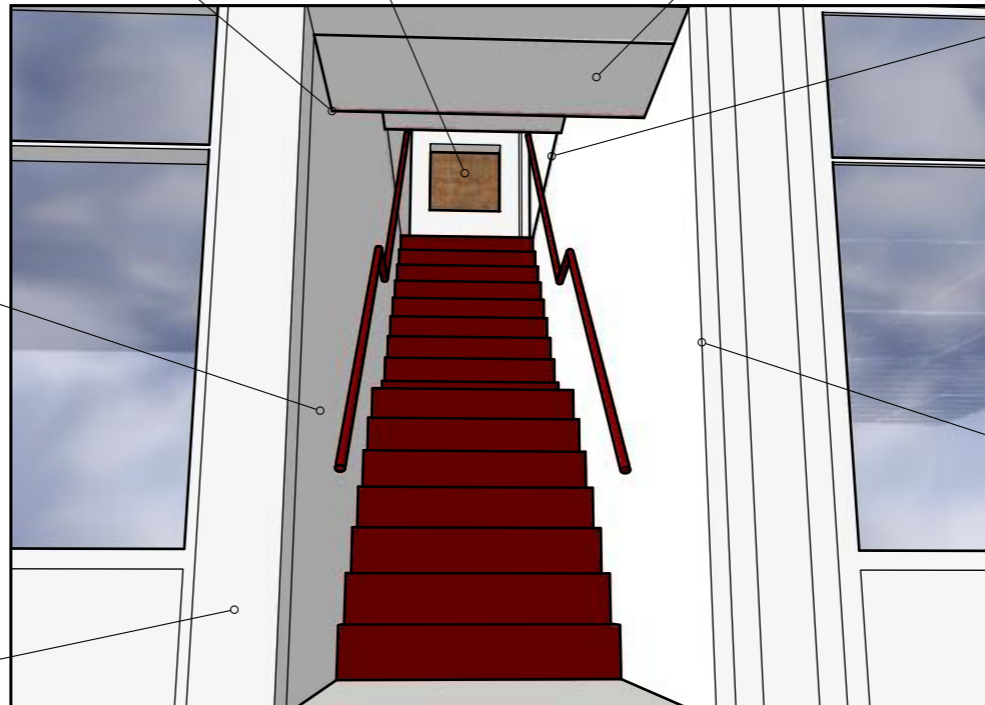
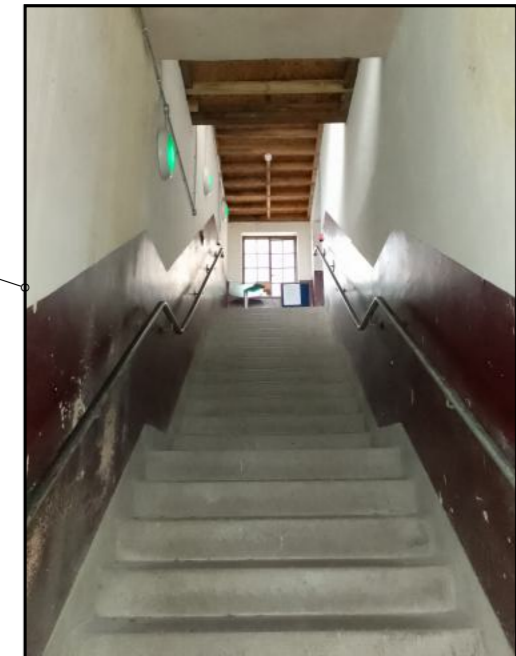
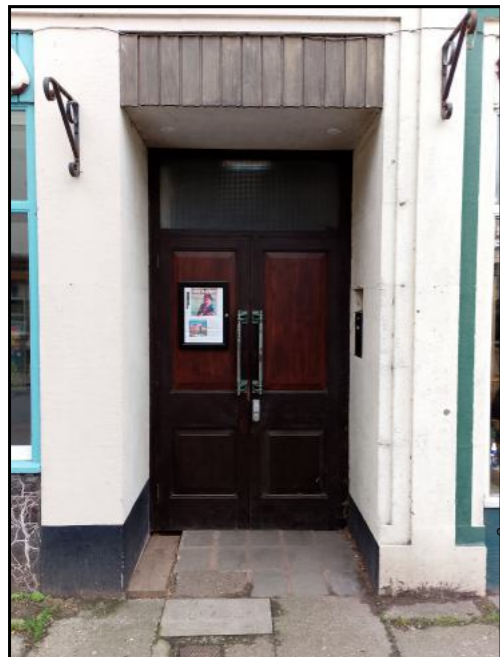
Front Entrance and Stairway Images

- Windows
 - o 4 windows.
 - o One above main door entrance, glazed with toughened, frosted glass.
 - o Two in the ceiling above the centre of the stairway.

- o One on the landing. Metal frame with single glazed glass in need of repair. Currently can be used.
- Doors
 - o There are 2 doors.
 - o 1 set of double wooden doors at the main entrance - currently lockable and in use as an emergency exit.

- o Fire alarm panel
 - o Area for clock weight
- Actions
 - o **Short-term**
 - Repair ceiling where needed, refit boarding, plaster and repaint.
 - Repair walls and repaint.

- Install chairlift to aid Hall accessibility.
 - Fix anti-slip fluorescent stair nosing for safety and visibility
 - Reattach handrail if needed
 - (Replace glass above front door with electronic information sign)
